Subject: 301 Mission Retrofit Supplemental Monitoring Report 068: Results as of August 24, 2022

INSTRUMENT LOCATION MAP
HORIZONTAL SURVEY CONTROL AND TARGET POINTS AT FIRST LEVEL

Millennium Tower Perimeter Pile Upgrade: Instrumentation Monitoring Data
City and County of San Francisco, California

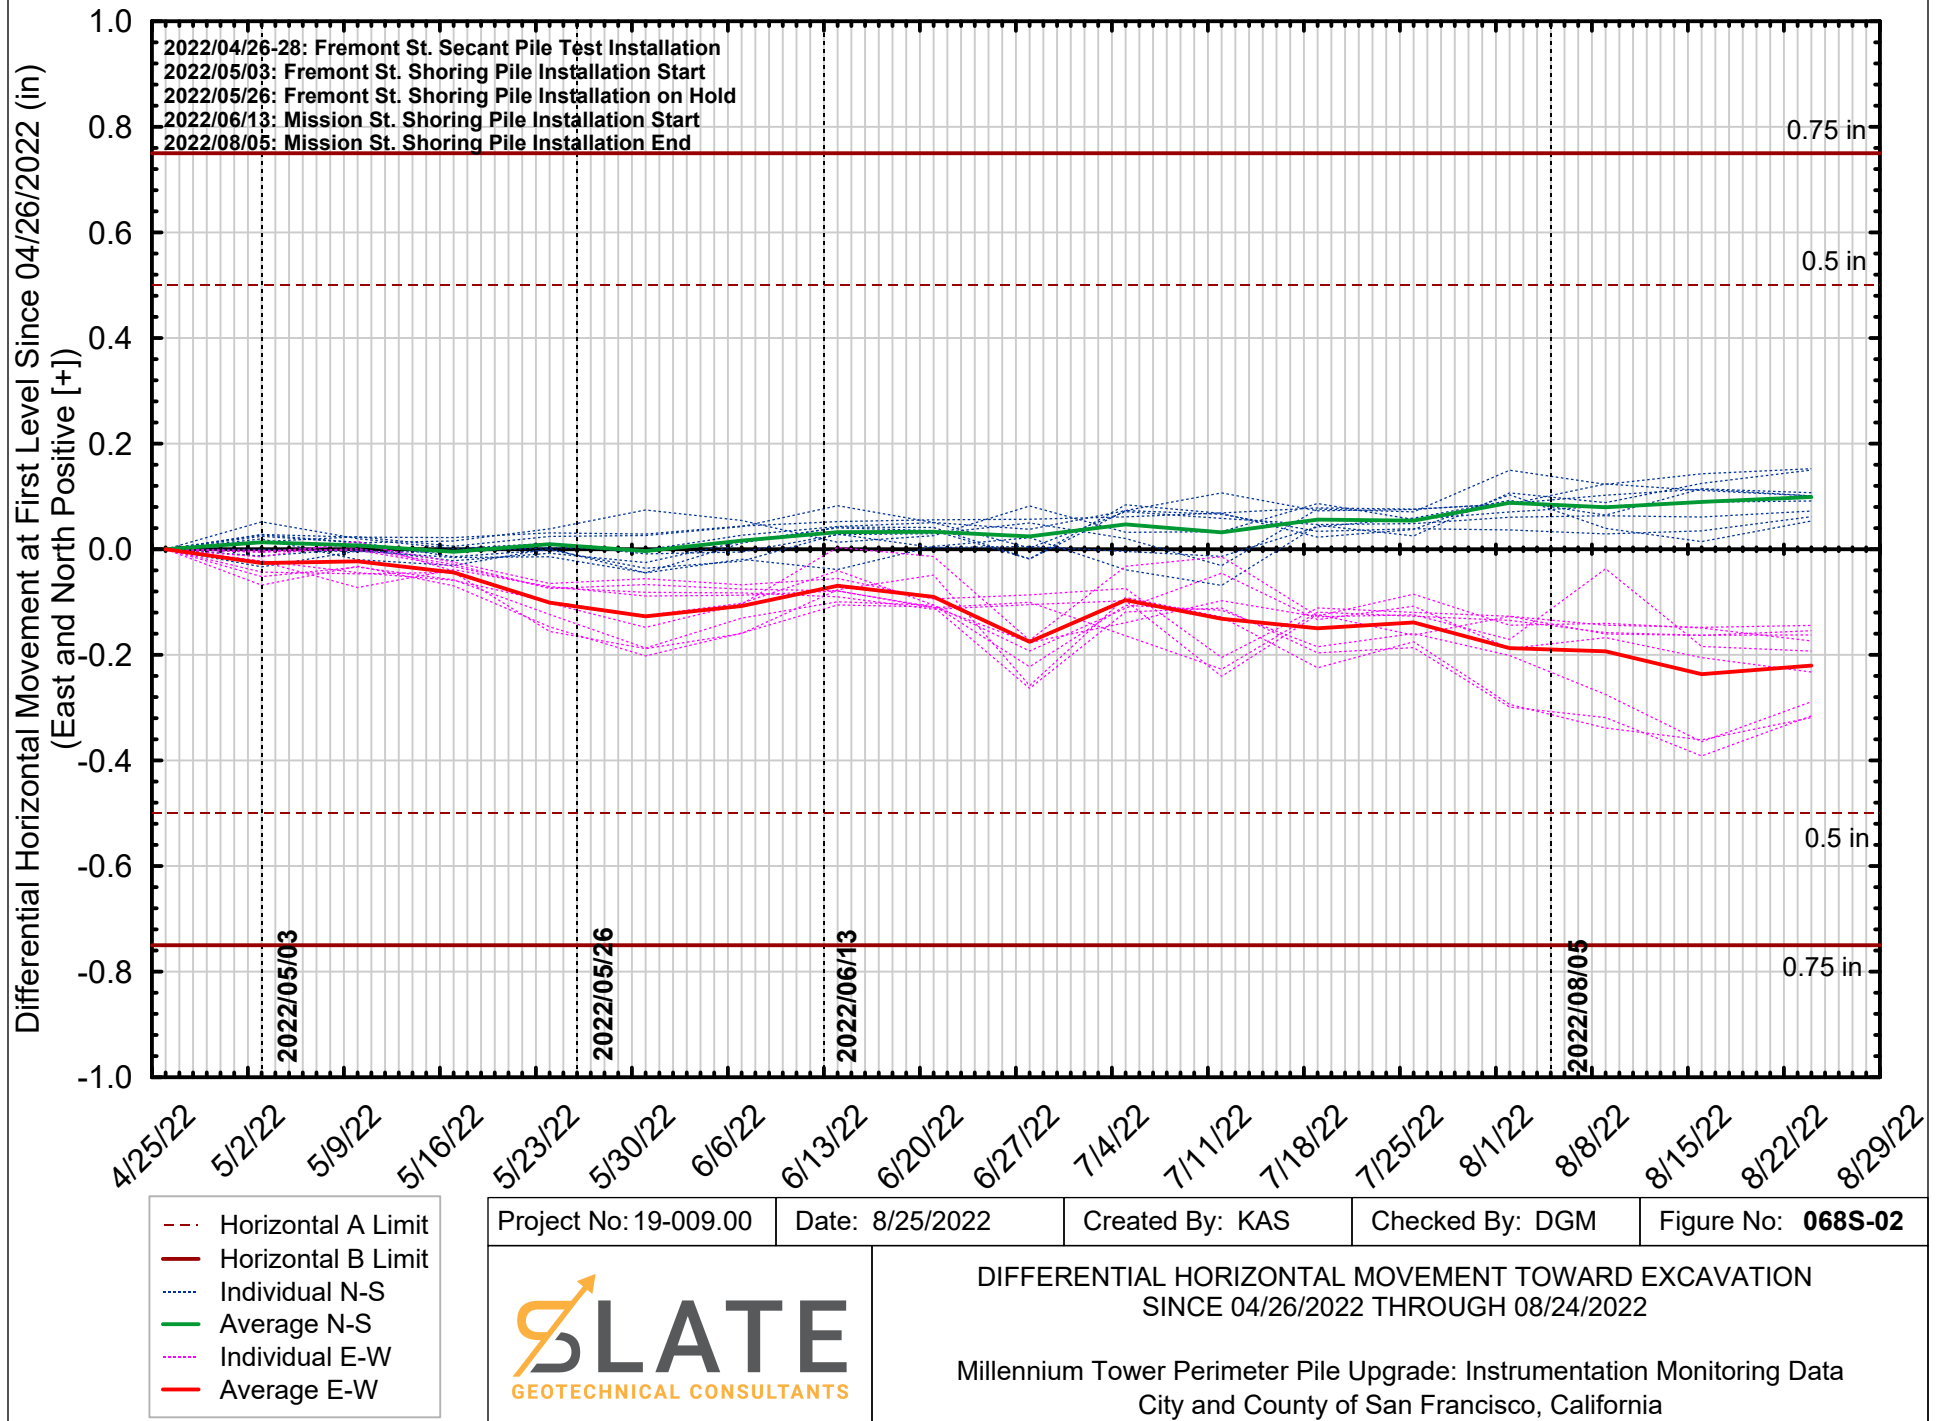
Figure S-02 – Differential Horizontal Movement Toward Excavation Since 04/26/2022 through 08/24/2022

Figure S-02 presents the differential horizontal movement toward the excavation at survey prisms installed at approximately one floor level above grade on the exterior of the building, as well as the average in each of the project north-south and east-west direction, since April 26, 2022, through August 24, 2022. Limits established in the aforementioned letter are included for reference.

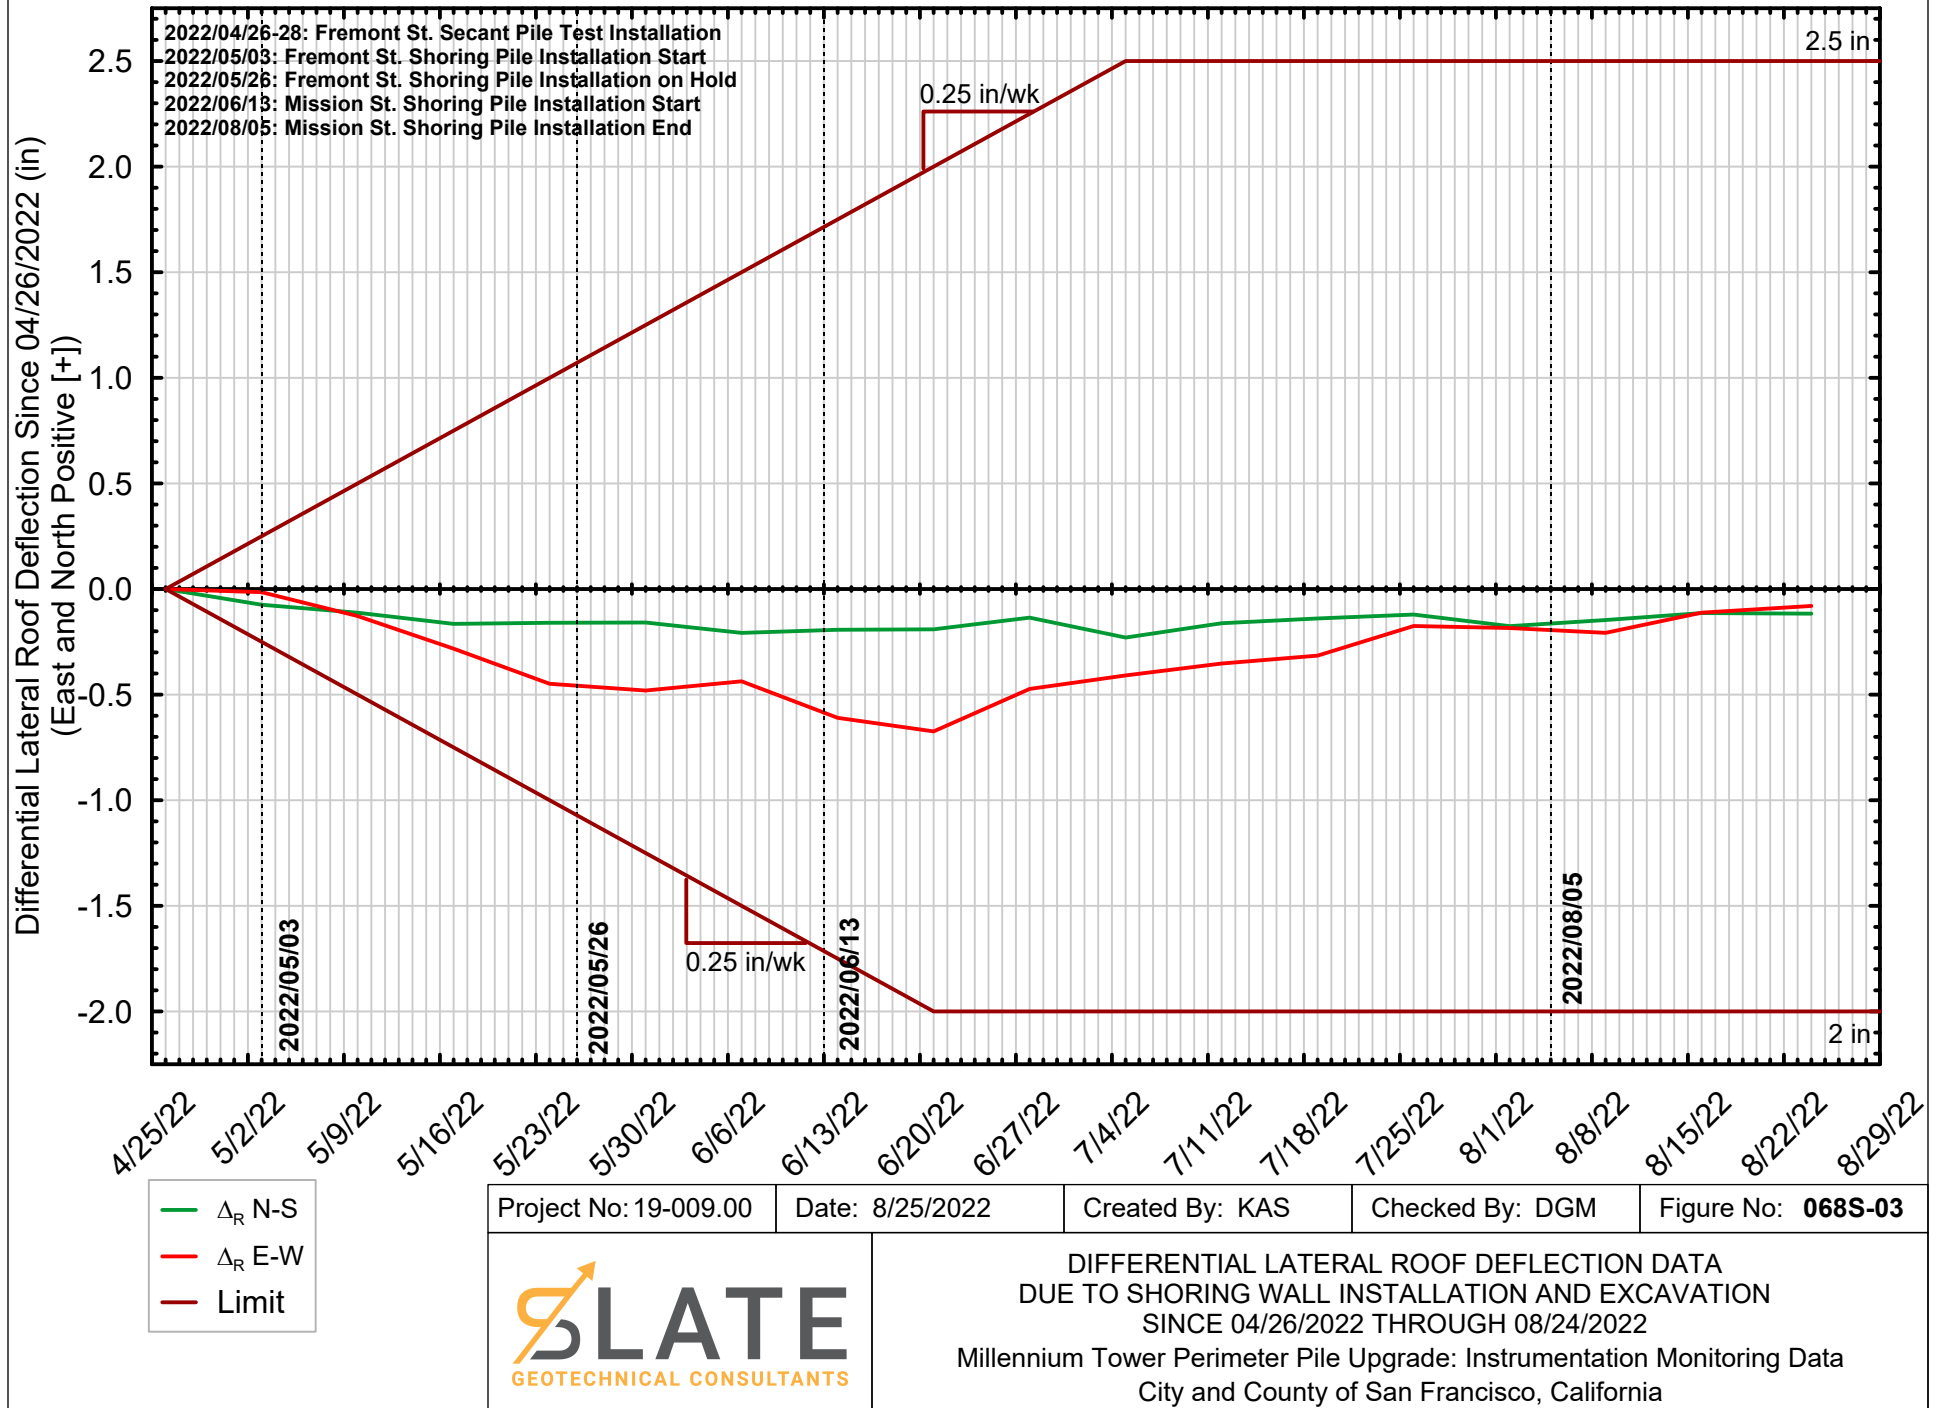
Figure S-03 – Differential Lateral Roof Deflection Data due to Shoring Wall Installation and Excavation since 04/26/2022 through 08/24/2022

Figure S-03 presents differential lateral roof deflection data due to shoring wall installation and excavation since April 26, 2022, through August 24, 2022. Limits established in the aforementioned letter are included for reference. Note that differential lateral roof deflection due to shoring wall installation and excavation is calculated following the aforementioned letter as:

where: Δ_R is the computed differential lateral roof deflection due to shoring wall installation and excavation;
 $\Delta_{R-prism}$ is the differential lateral roof deflection obtained from prism data;
 Δ_H is the average differential horizontal movement "at-grade";
 α is the weekly lateral roof deflection rate (computed as described below); and,
 T is the number of weeks since initiation of shoring wall installation or excavation.

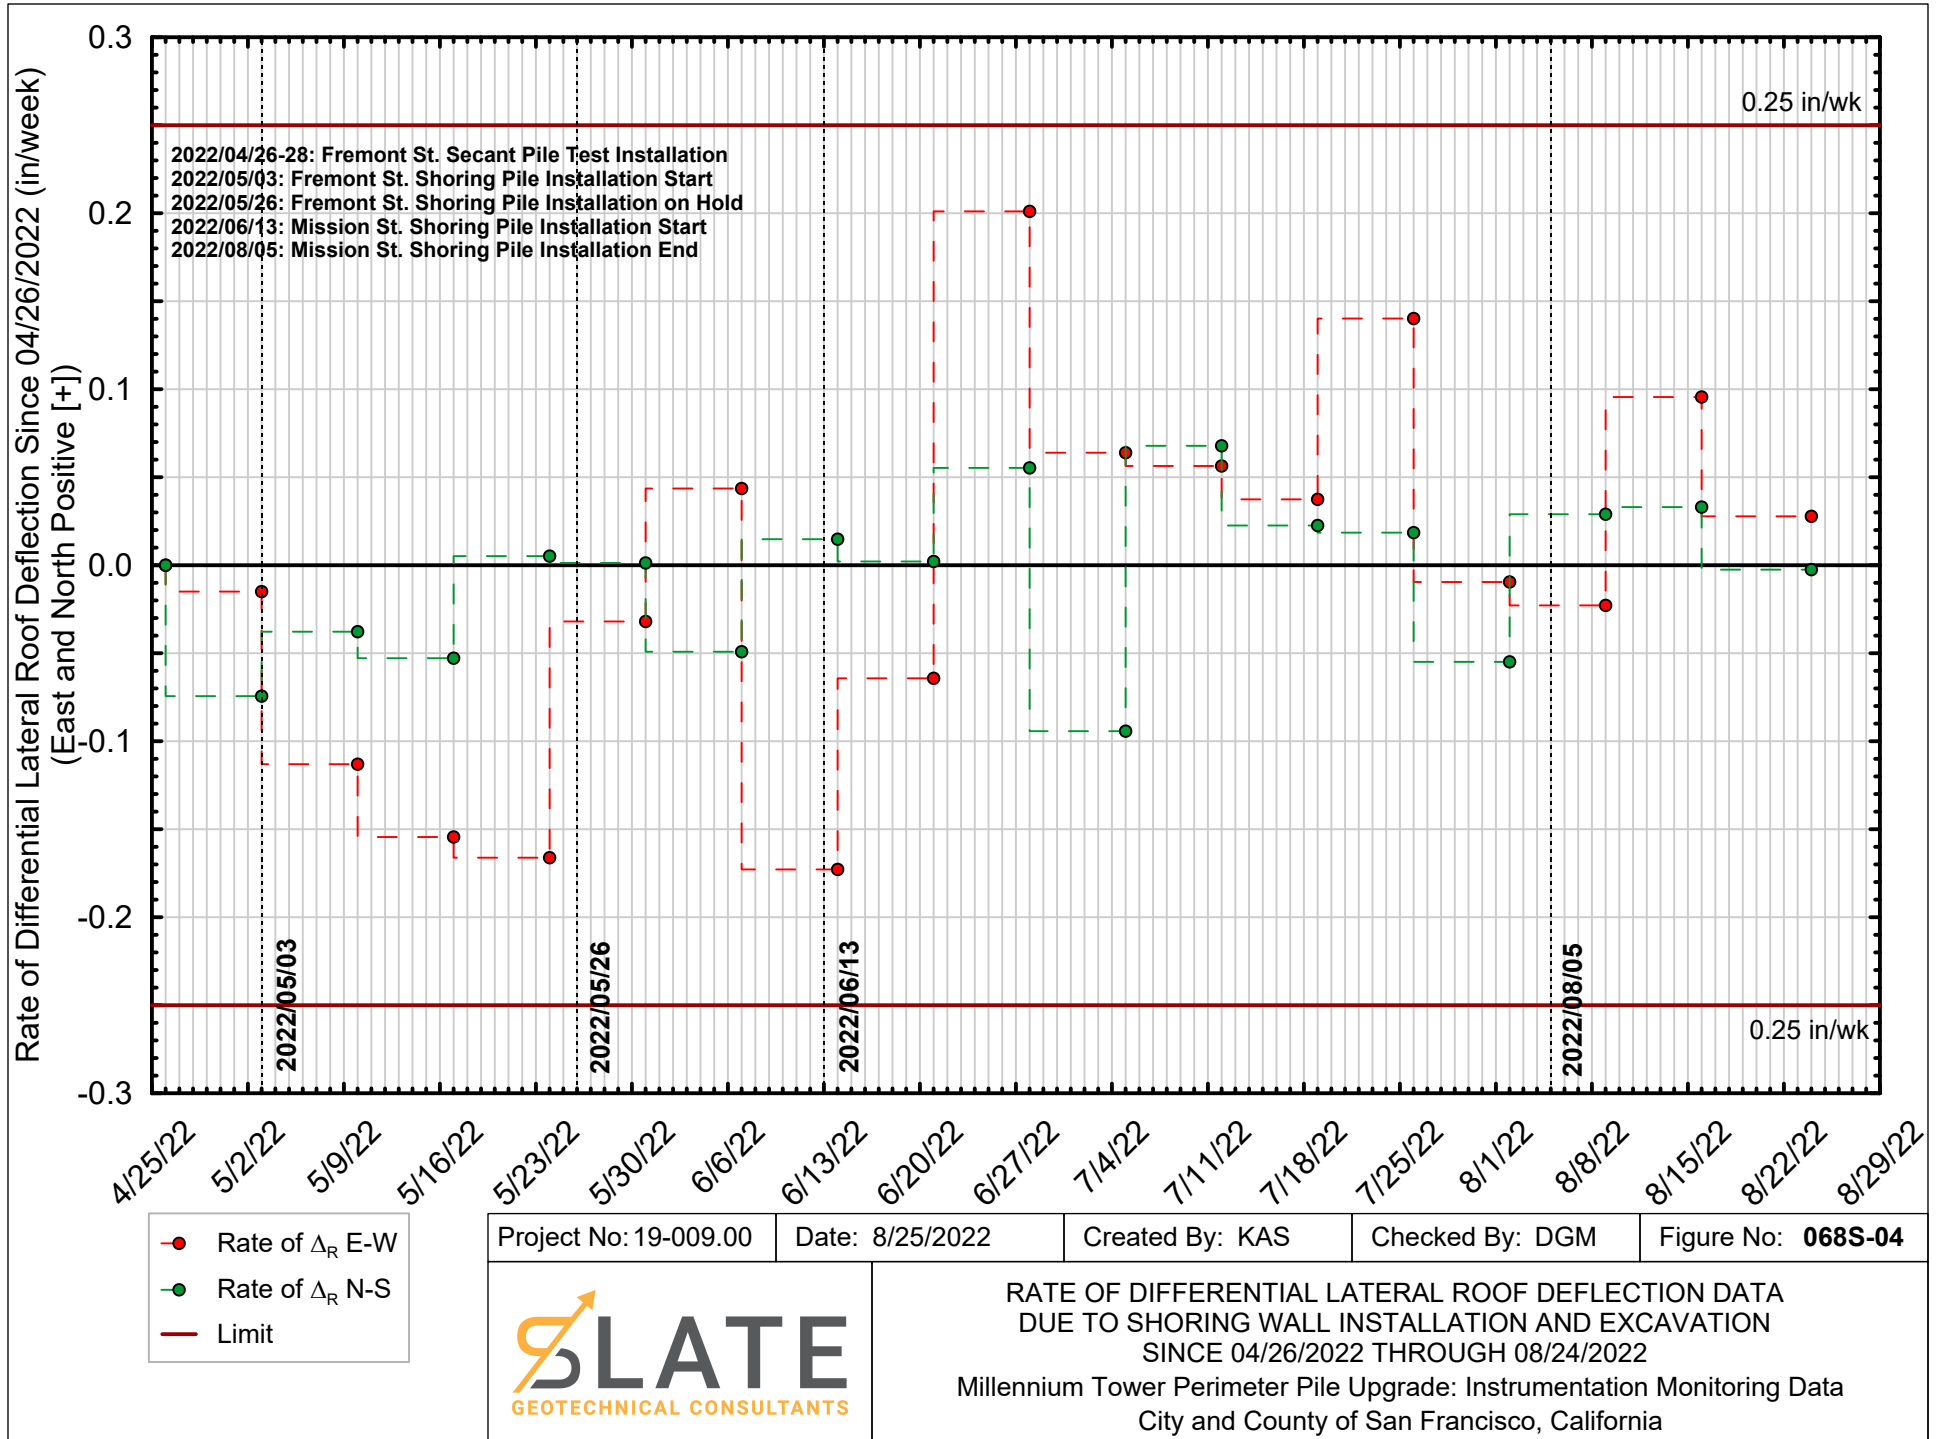
Figure S-04 – Rate of Differential Lateral Roof Deflection Data due to Shoring Wall Installation and Excavation since 04/26/2022 through 08/24/2022

Figure S-04 presents rates of differential lateral roof deflection data due to shoring wall installation and excavation since April 26, 2022, through August 24, 2022. Limits established in the aforementioned letter are included for reference. Note that the rates are calculated as:

where: t is an index representing the current instance in time; and
 $t - 1$ is an index representing the previous instance in time.
